# *Homeguard Home Inspections*

## Property Inspection Report

123 Sample Rd, Sample, NY 11111  
Inspection prepared for: Mr Sample & Mrs. Sample  
Date of Inspection: 3/11/2015 Time: 8:30am

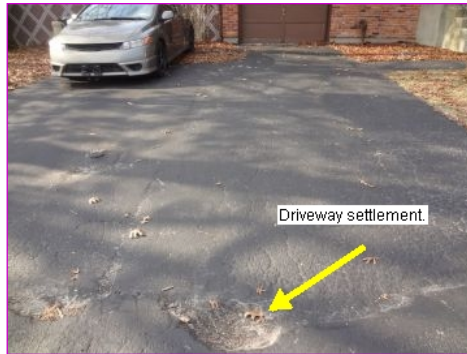
## 2. Driveway Condition

- The Inspector observed few deficiencies in the condition of the driveway at the time of the inspection. Notable exceptions will be listed in this report.
- Significant cracks visible in the driveway at the time of the inspection should be filled with an appropriate sealant to avoid continued damage to the driveway surface from freezing moisture.

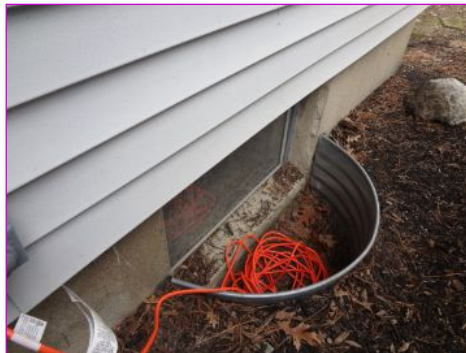
- One or more window wells lacked covers at the time of the inspection. This condition can be hazardous to small children and may trap pests. The inspector recommends installation of window well covers.

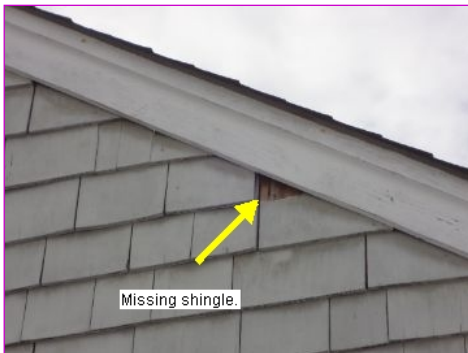
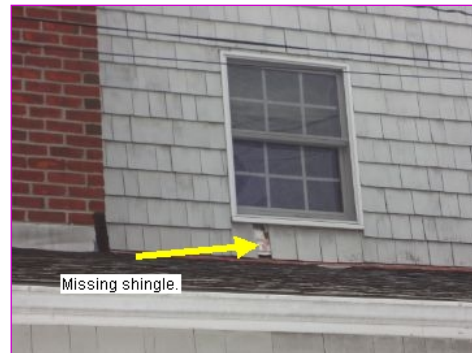
• Some wood shingles covering exterior walls observed at the time of the inspection were split. Splitting is typically due to age and exposure to weather and an often-used rule of thumb calls for replacement when 30% or greater of shingles are split. The percentage of split shingles covering exterior walls appeared to be lower than 30% at the time of the inspection.

• The wood shingle exterior wall covering was missing shingles at the time of the inspection. Missing shingles should be replaced to help prevent damage from moisture intrusion to the home materials, the exterior wall structure and to prevent development of microbial growth such as mold. All work should be performed by a qualified contractor.

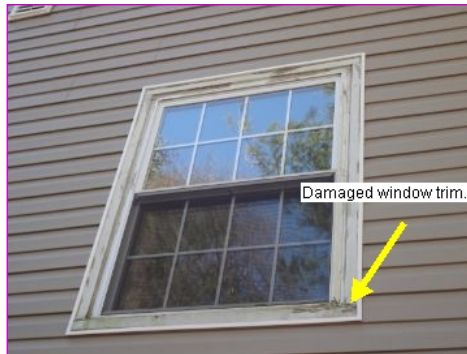
- Window trim at the home exhibited moderate weathering and deterioration commensurate with its age.

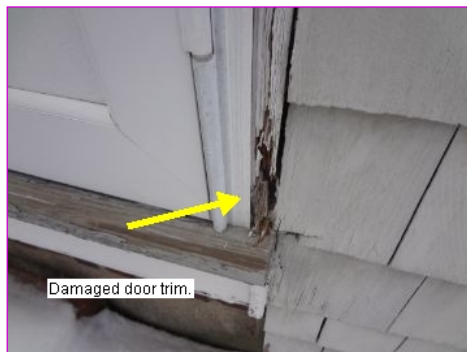
### 6. Door Trim

- Door trim at the home exhibited severe weathering and deterioration. It appeared to be adequately protecting the structure at the time of the inspection.

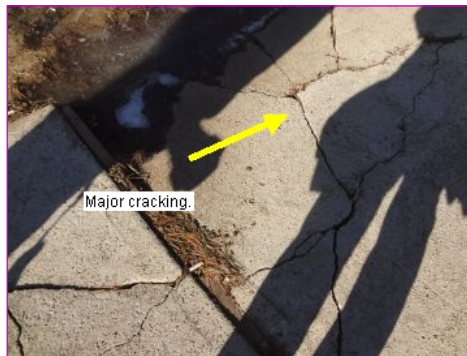
- The patio surface had severe cracking visible at the time of the inspection. The source of cracking appeared to be soil movement. Determining the cause and likelihood of continuing damage will require that you consult with a soils engineer. The Inspector recommends that cracks be filled with an appropriate material to help prevent continued deterioration.

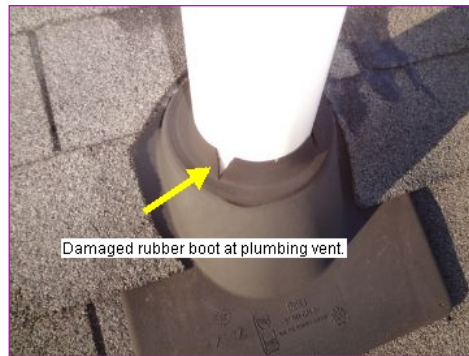
Page 17 Item: 1	Plumbing Vents	<ul style="list-style-type: none"> <li>The rubber boot at a roof plumbing vent pipe was damaged and may allow moisture intrusion of the roof assembly. The Inspector recommends replacement by a qualified roofing contractor.</li> </ul>
-----------------	----------------	---

- The rubber boot at a roof plumbing vent pipe was damaged and may allow moisture intrusion of the roof assembly. The Inspector recommends replacement by a qualified roofing contractor.

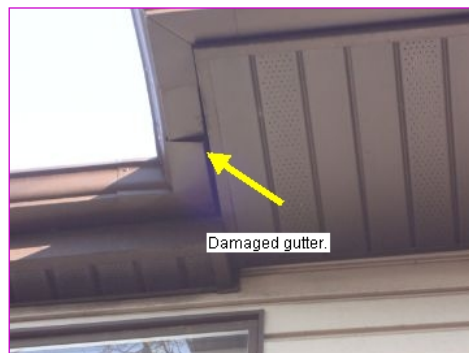
- The Inspector observed few deficiencies in the condition of the gutters. Notable exceptions will be listed in this report.
- Debris visible in the gutters at the time of the inspection should be removed to encourage proper drainage.

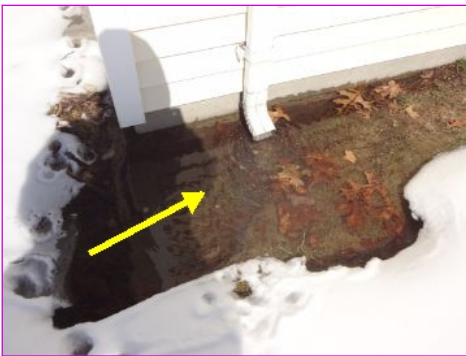
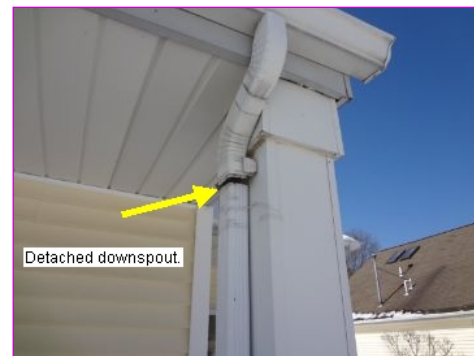
## 4. Downspouts

- One or more downspouts designed to discharge roof drainage needed to be re-connected in order to properly control roof run-off. Disconnected downspouts can cause excessively high moisture levels in soil next to the foundation that can effect the ability of the soil to support the weight of the structure above and/or can cause damage related to soil/foundation movement. The Inspector recommends re-connection of any disconnected downspouts to help protect the home structure. All work should be performed by a qualified contractor.

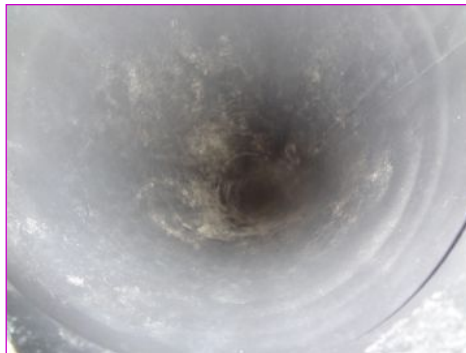
- The portions of the chimney flue visible from the roof was dirty at the time of the inspection. Because the accumulation of flammable materials in the flue as a natural result of the wood-burning process is a potential fire hazard, the inspector recommends that the flue be cleaned by a qualified contractor.

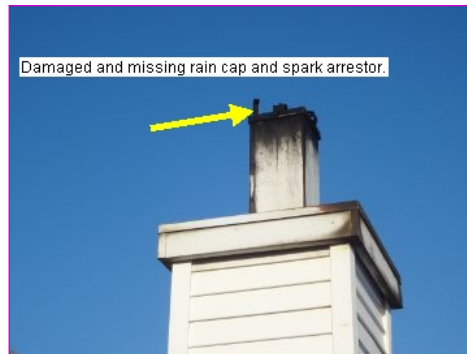
## 5. Spark Arrestor

Page 20 Item: 5	Spark Arrestor	<ul style="list-style-type: none"> <li>The inspector noted that part of the screen that prevents animals from entering the chimney was missing. We recommend replacing any missing sections of this screen.</li> </ul>
-----------------	----------------	--

- The inspector noted that part of the screen that prevents animals from entering the chimney was missing. We recommend replacing any missing sections of this screen.

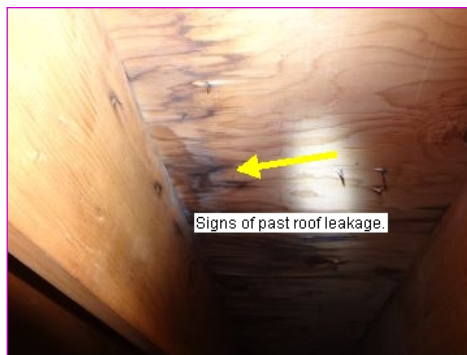
- Roof sheathing had areas of discoloration that appeared to be the result of roof leakage. Although the roof had experienced recent rain, sheathing did not have elevated moisture levels at the time of the inspection. The source of the leak appeared to have been corrected.

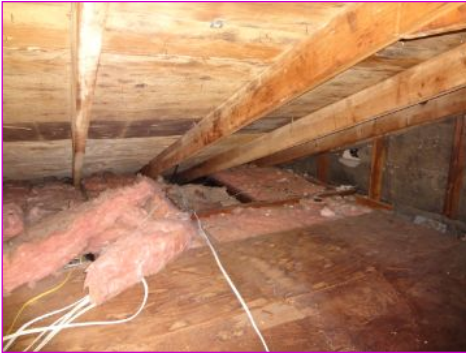
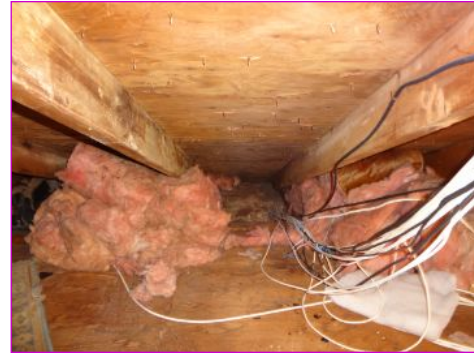
- Thermal insulation installed to limit heat gain and loss in the living space did not appear to meet widely-accepted modern standards. To reduce energy consumption and heating/cooling costs, the inspector recommends that additional thermal insulation be added to meet modern standards. A qualified insulation contractor should be able to advise you capably.

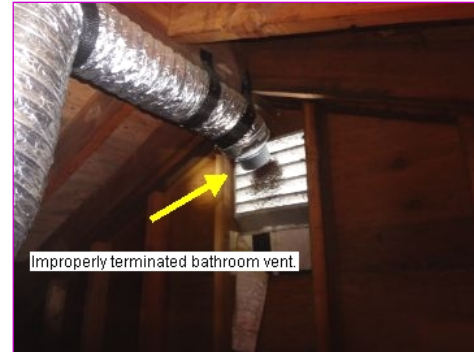
Page 28 Item: 11	Room Vent Terminations	<ul style="list-style-type: none"> <li>A bathroom exhaust vent terminated in the attic instead of at the home exterior. This condition can raise moisture vapor levels in the attic to the point at which home materials are damaged or unhealthy conditions related to mold develop. The Inspector recommends correction by a qualified contractor.</li> </ul>
Page 28 Item: 12	Attic Electrical	<ul style="list-style-type: none"> <li>Energized electrical splices not contained within a junction box and exposed to touch were visible in the attic at the time of the inspection. Electrical splices should be contained within an approved junction box with a cover plate installed. This condition is a shock/electrocution and potential fire hazard and should be corrected by a qualified electrical contractor.</li> </ul>

The Inspector recommends correction by a qualified contractor.

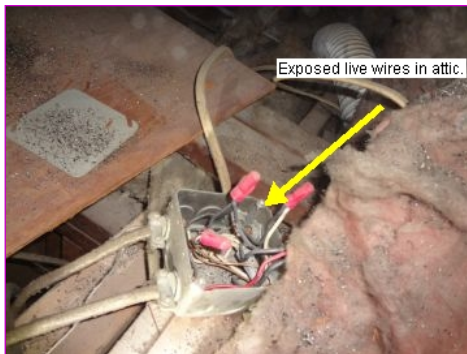
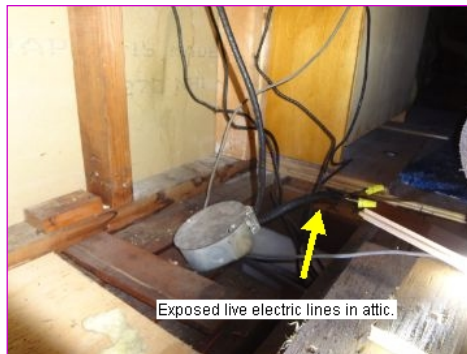
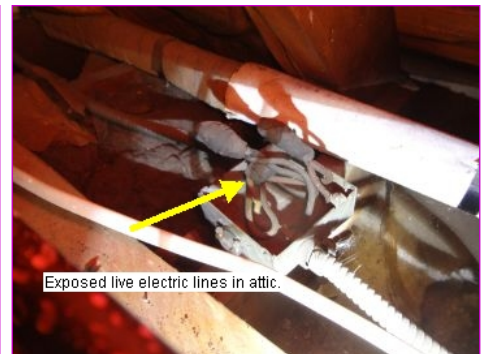
## 12. Attic Electrical

- Energized electrical splices not contained within a junction box and exposed to touch were visible in the attic at the time of the inspection. Electrical splices should be contained within an approved junction box with a cover plate installed. This condition is a shock/electrocution and potential fire hazard and should be corrected by a qualified electrical contractor.

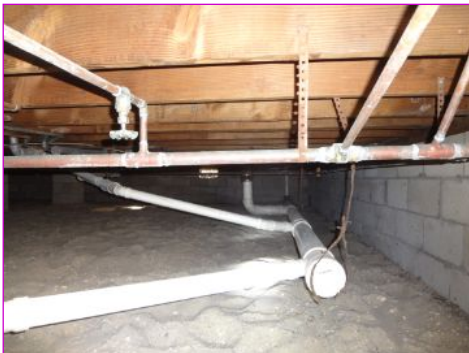
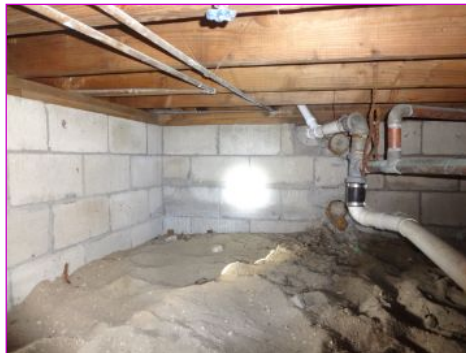
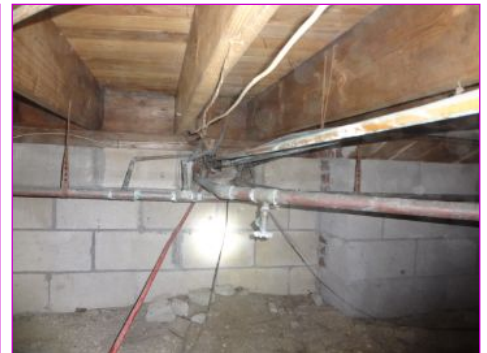
The source of moisture should be identified and the condition corrected. If the odor persists, consider consulting with a qualified industrial hygienist to determine the source of the odor and gain an idea of options and costs for correction.

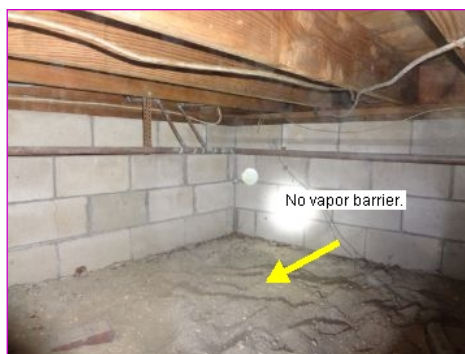
- The crawlspace had a dirt floor.
- No soil cover was installed at the time of the inspection. Soil covers help reduce humidity levels in crawlspaces by limiting moisture evaporation into the air from soil. Reducing humidity levels can help prevent conditions that encourage mold growth and wood decay.

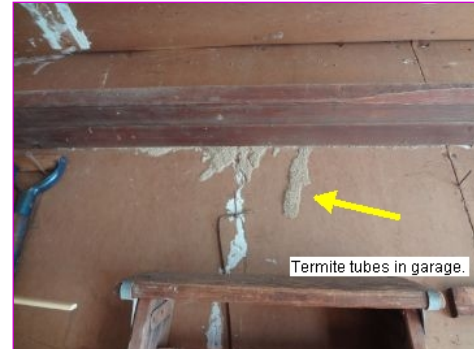
Page 33 Item: 1	Termites	<ul style="list-style-type: none"> <li>• Tubes visible in the garage indicated termite infestation. The Inspector recommends an inspection and any necessary work be performed by a qualified pest control contractor.</li> </ul>
-----------------	----------	---

- Tubes visible in the garage indicated termite infestation. The Inspector recommends an inspection and any necessary work be performed by a qualified pest control contractor.

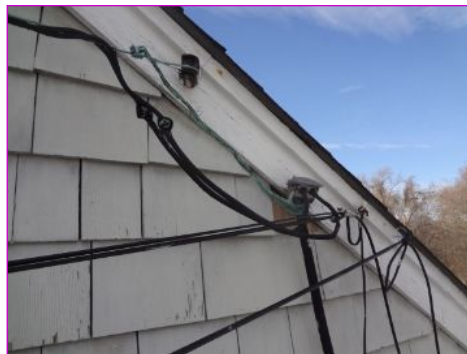
Page 36 Item: 1	Service Drop	<ul style="list-style-type: none"> <li>• The overhead service-drop conductors were an older, cloth-covered type which had frayed and left energized wires exposed to touch. The Inspector recommends replacement by the electric utility provider.</li> </ul>
-----------------	--------------	---

- The electrical service was overhead.
- The overhead service-drop conductors attached directly to the home exterior. Although this is an outdated practice, the Inspector observed no deficiencies in the condition of the attachment at the time of the inspection.
- The overhead service-drop conductors were an older, cloth-covered type which had frayed and left energized wires exposed to touch. The Inspector recommends replacement buy the electric utility provider.

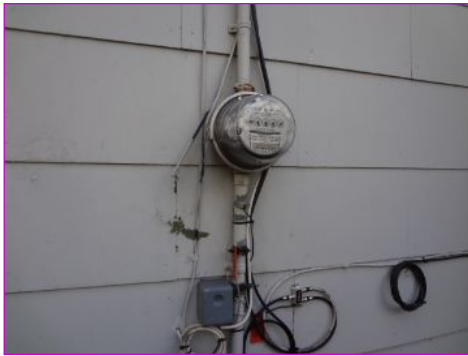
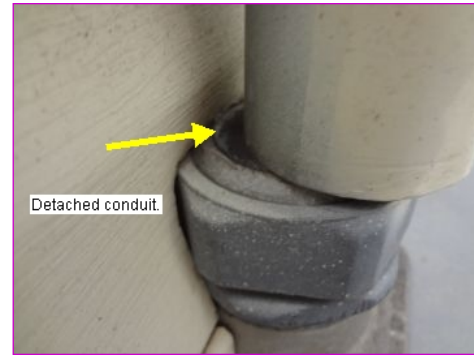
Page 37 Item: 2	Electric Meter Condition	<ul style="list-style-type: none"> <li>• Detached conduit at the top of the meter will allow moisture intrusion of the meter housing. This could cause corrosion of electrical components in the meter. This condition should be corrected by the electrical utility.</li> </ul>
-----------------	--------------------------	--

- Detached conduit at the top of the meter will allow moisture intrusion of the meter housing. This could cause corrosion of electrical components in the meter. This condition should be corrected by the electrical utility.

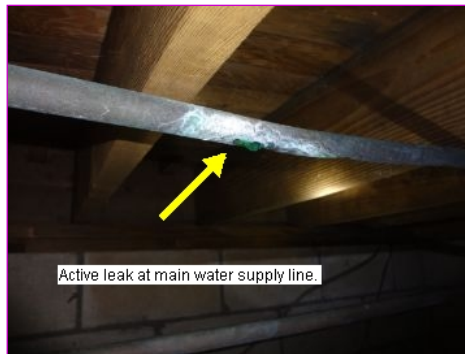
Page 42 Item: 1	Main Water Pipe	<ul style="list-style-type: none"> <li>The inspector observed an active water leak at the main water supply pipe in the crawl space. We recommend having a licensed plumbing contractor evaluate and correct this condition.</li> </ul>
-----------------	-----------------	---

- The main water supply pipe was 3/4-inch copperpipe.
- The inspector observed an active water leak at the main water supply pipe in the crawl space. We recommend having a licensed plumbing contractor evaluate and correct this condition.

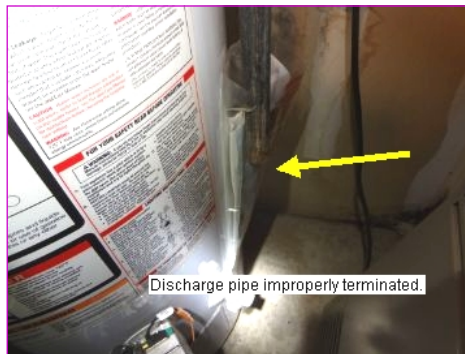
## 11. TPR Discharge Pipe

Page 46 Item: 11	TPR Discharge Pipe	<ul style="list-style-type: none"> <li>The discharge pipe of this water heater temperature/pressure relief (TPR) valve was terminated more than 6 inches above the floor. This condition could result in scalding if the pressure relief valve were activated while a person was nearby. The Inspector recommends correction by a qualified plumbing or HVAC contractor.</li> </ul>
------------------	--------------------	---

- The discharge pipe of this water heater temperature/pressure relief (TPR) valve was terminated more than 6 inches above the floor. This condition could result in scalding if the pressure relief valve were activated while a person was nearby. The Inspector recommends correction by a qualified plumbing or HVAC contractor.

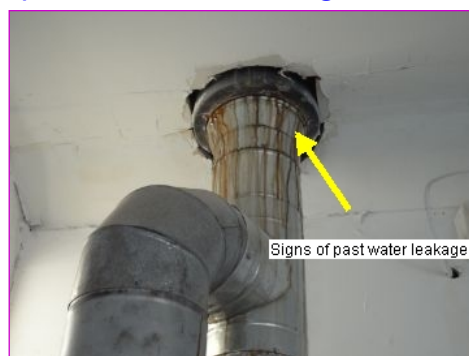
- The inspector observed signs of past water/roof leakage at the combustion flue.

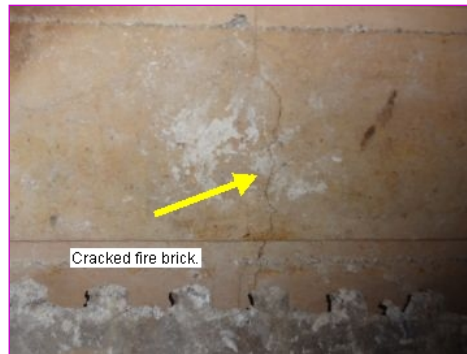
- Firebrick lining the wall of the firebox of the wood-burning fireplace in the main floor family room was cracked. This condition may allow the toxic, corrosive products of combustion to damage the chimney structure or enter the living space. The Inspector recommends repair by a qualified contractor.

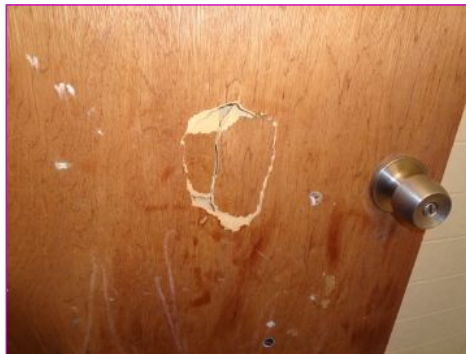
- At the time of the inspection, the Inspector observed few deficiencies in the condition of the interior doors. Notable exceptions will be listed in this report.
- Interior doors in the home exhibited light damage or deterioration commensurate with the age of the home.
- Interior entry doors to rooms containing heating supply registers but no return air registers had inadequate gaps at the bottoms that will not allow adequate air flow between the supply registers located in these rooms and the return air registers in the hall. This condition can result in pressurization of these rooms that can reduce the amount of conditioned air entering the rooms. The inspector recommends the door bottoms be cut to provide gaps of at least 3/4-inch.

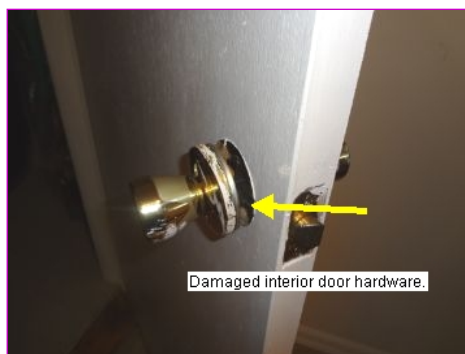
### 5. Interior Door Hardware

- Door hardware at an interior door in the hallway closet was old and showed minor deterioration commensurate with its age at the time of the inspection.

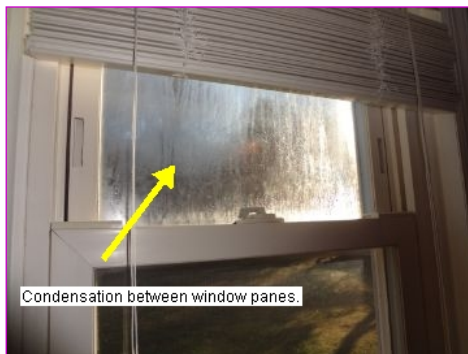
- Condensation visible in the double-pane glazing of a window in the living room indicated a loss of thermal integrity. The Inspector recommends that before the expiration of your Inspection Objection Deadline you consult with a qualified contractor to discuss options and costs for repair or replacement.
- One or more window in the living room had a cracked or broken pane.

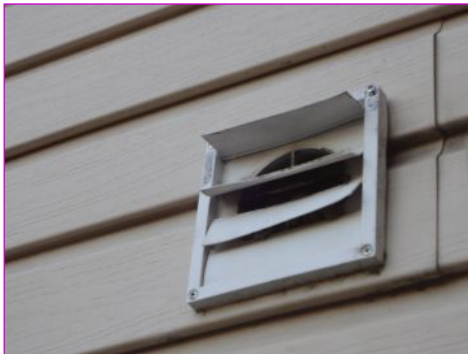
- The dryer was vented using a flexible, ribbed foil vent. This type of dryer exhaust vent is more likely to accumulate lint than a smooth metal vent, creating a potential fire hazard. Excessive lint accumulation can also increase drying time and shorten the dryer's lifespan. The Inspector recommends replacing this plastic vent with a properly-installed, UL-approved dryer vent. All work should be performed by a qualified contractor.
