# *Homeguard Home Inspections*

## Property Inspection Report

123 Sample Rd, Sample, NY 11111  
Inspection prepared for: Mr Sample & Mrs. Sample  
Date of Inspection: 3/11/2015 Time: 8:30am

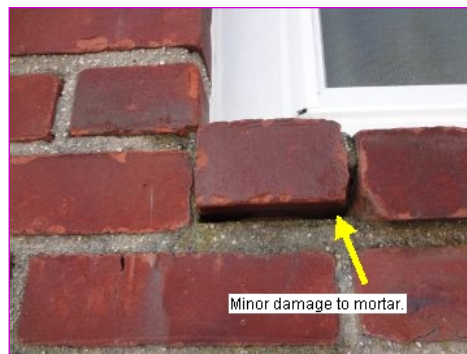
### 6. Brick Damage and Deterioration

- The brick exterior walls had damage visible above and below windows that should be repaired by a qualified masonry contractor before this condition develops into more serious damage.

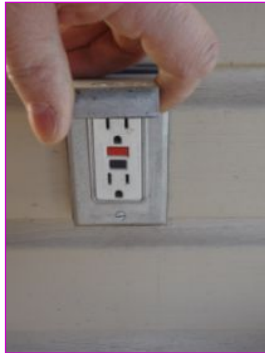
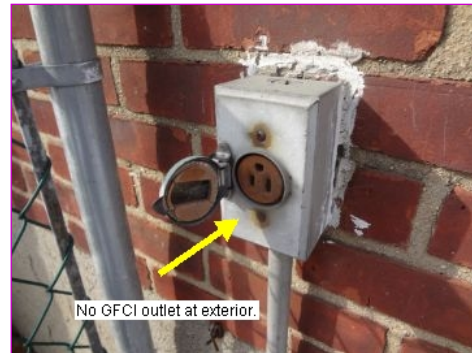
Page 12 Item: 1	Exterior Electrical Receptacles	<ul style="list-style-type: none"> <li>Exterior receptacles at the home were not protected from weather and had no Ground Fault Circuit Interrupter (GFCI) protection. Although GFCI protection of exterior circuits may not have been required at the time in which this home was built, as general knowledge of safe building practices has improved with the passage of time, building standards have changed to reflect current understanding. The Inspector recommends updating the existing exterior electrical circuits to include GFCI protection. This can be achieved by:               <ol style="list-style-type: none"> <li>Replacing the current standard receptacles with GFCI receptacles.</li> <li>Replacing the electrical circuit receptacles located closest to the main electrical service panel with a GFCI receptacles.</li> <li>Replacing the breaker currently protecting the electrical circuit that supplies these receptacles with a GFCI breaker.</li> </ol> </li> </ul>

1. Replacing the current standard receptacles with GFCI receptacles.
2. Replacing the electrical circuit receptacles located closest to the main electrical service panel with a GFCI receptacles.
3. Replacing the breaker currently protecting the electrical circuit that supplies these receptacles with a GFCI breaker.

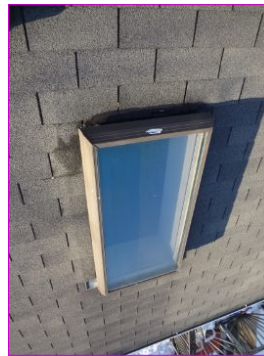
- Skylight installation quality was poor, increasing the chances of leakage.

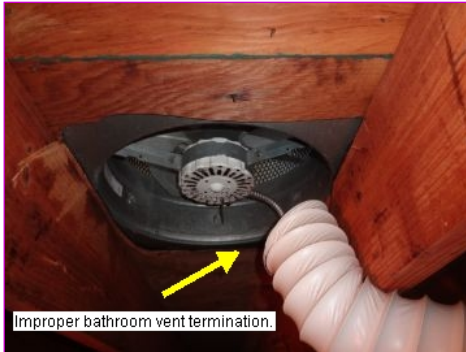
Page 28 Item: 11	Room Vent Terminations	<ul style="list-style-type: none"> <li>A bathroom exhaust vent terminated in the attic instead of at the home exterior. This condition can raise moisture vapor levels in the attic to the point at which home materials are damaged or unhealthy conditions related to mold develop. The Inspector recommends correction by a qualified contractor.</li> </ul>
Page 28 Item: 12	Attic Electrical	<ul style="list-style-type: none"> <li>Energized electrical splices not contained within a junction box and exposed to touch were visible in the attic at the time of the inspection. Electrical splices should be contained within an approved junction box with a cover plate installed. This condition is a shock/electrocution and potential fire hazard and should be corrected by a qualified electrical contractor.</li> </ul>

- A bathroom exhaust vent terminated in the attic instead of at the home exterior. This condition can raise moisture vapor levels in the attic to the point at which home materials are damaged or unhealthy conditions related to mold develop.

The Inspector recommends correction by a qualified contractor.

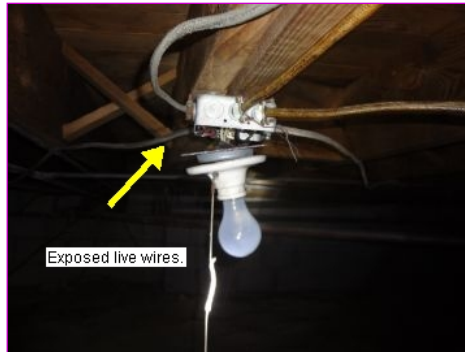
Page 31 Item: 4	Electrical	<ul style="list-style-type: none"> <li>The inspector observed a light fixture in the crawlspace which was detached from the junction box exposing live electrical wires. We recommend having a qualified contractor resecured the light fixture.</li> </ul>
-----------------	------------	---

- Poorly supported electrical wires in the crawlspace should be corrected by a qualified electrical contractor.
- The inspector observed a light fixture in the crawlspace which was detached from the junction box exposing live electrical wires. We recommend having a qualified contractor resecured the light fixture.

*The inspector observed a light fixture in the crawlspace which was detached from the junction box exposing live electrical wires. We recommend having a qualified contractor resecured the light fixture.*

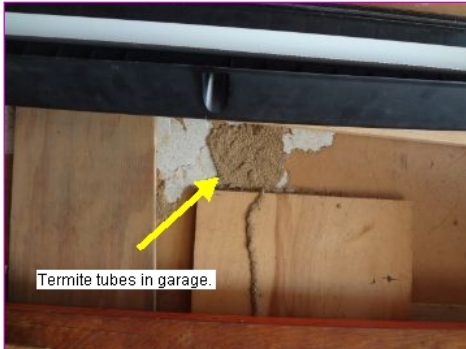
Page 33 Item: 1	Termites	<ul style="list-style-type: none"> <li>• Tubes visible in the garage indicated termite infestation. The Inspector recommends an inspection and any necessary work be performed by a qualified pest control contractor.</li> </ul>
-----------------	----------	---

- Tubes visible in the garage indicated termite infestation. The Inspector recommends an inspection and any necessary work be performed by a qualified pest control contractor.

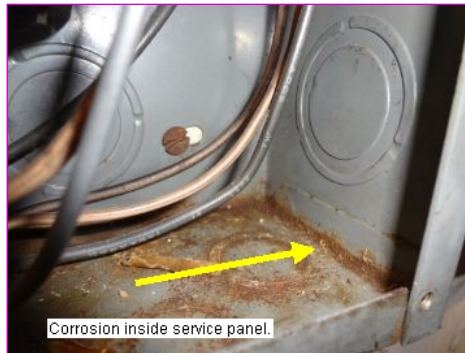
Page 38 Item: 6	Cabinet Condition	<ul style="list-style-type: none"> <li>The service panel cabinet interior exhibited moderate amounts of corrosion indicating some moisture intrusion. The Inspector recommends maintenance be performed by a qualified contractor to ensure that electrical connections have not deteriorated.</li> </ul>
Page 38 Item: 8	Cabinet Amperage Rating	<ul style="list-style-type: none"> <li>The service panel label listed the panel rating at 60 amps. A 60 amp service is considered obsolete by modern standards and for safety reasons the Inspector recommends that you consult with a qualified electrical contractor to discuss options and prices for upgrading the electrical service.</li> </ul>
Page 40 Item: 14	Service Panel General Condition	<ul style="list-style-type: none"> <li>The service panel appeared to be original and was outdated. Service panels of this type and age were not designed to handle the larger loads placed upon service panel equipment by electrical appliances commonly found in modern homes. This system is a potential fire hazard. The Inspector recommends upgrading to a modern service panel. If you do not upgrade, it's important that you have the electrical system evaluated by a qualified electrical contractor to determine the limitations connected with its continued use.</li> </ul>

- The service panel cabinet interior exhibited moderate amounts of corrosion indicating some moisture intrusion. The Inspector recommends maintenance be performed by a qualified contractor to ensure that electrical connections have not deteriorated.

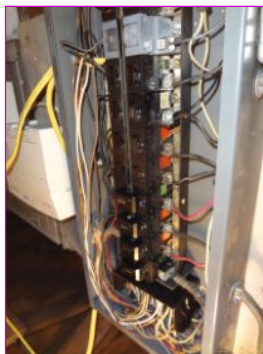
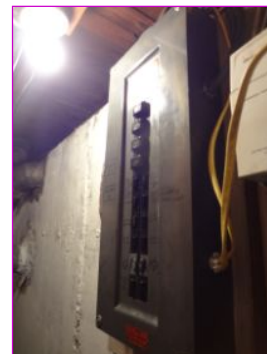
- The service panel appeared to be original and was outdated. Service panels of this type and age were not designed to handle the larger loads placed upon service panel equipment by electrical appliances commonly found in modern homes. This system is a potential fire hazard. The Inspector recommends upgrading to a modern service panel. If you do not upgrade, it's important that you have the electrical system evaluated by a qualified electrical contractor to determine the limitations connected with its continued use.

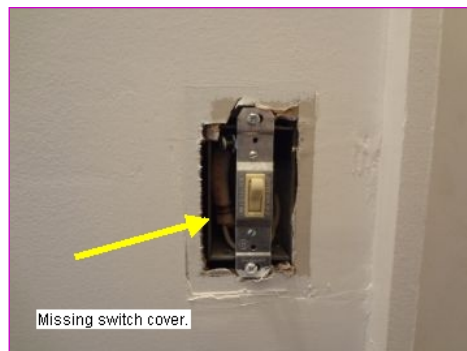
- At the time of the inspection, a switch cover plate was missing in the dining room. This condition left energized electrical components exposed to touch, a shock/electrocution hazard. The Inspector recommends that a listed cover plate be installed by a qualified electrical contractor.

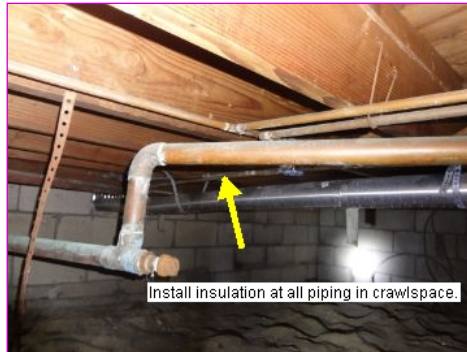
- At the time of the inspection, the Inspector observed few deficiencies in the condition of most visible water supply pipes. Notable exceptions will be listed in this report.
- The Inspector recommends that uninsulated water supply pipes in the crawlspace be insulated by a qualified contractor to save on water heating costs and to help prevent damage from freezing pipes.

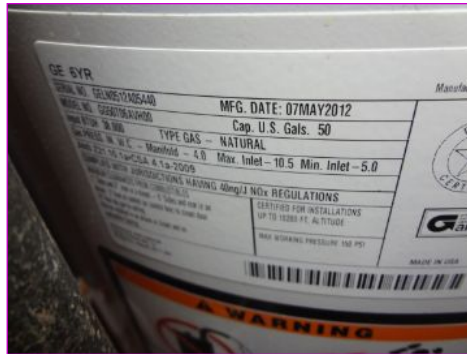
- The photo shows the data plate of the water heater.
- This water heater model number was GG50T06AVH00.
- This water heater serial number was GELN0512A05440.
- The date of manufacture for this water heater appeared to be 01/01/2008.
- The water heater was manufactured by General Electric.
- Water heater capacity was 50 gallons.

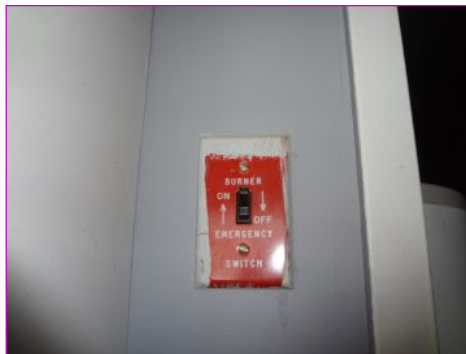
- The photo shows the electrical shut-off for the boiler.

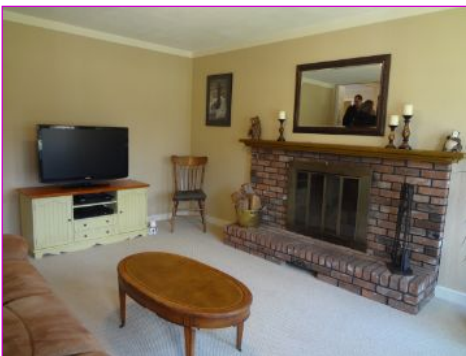
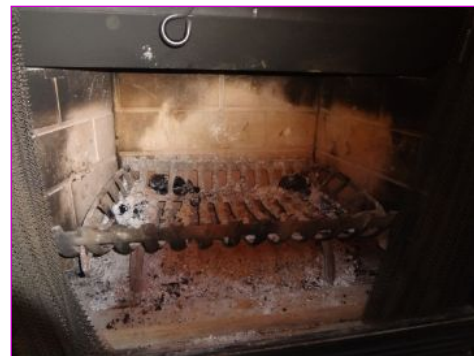
- The home contained a wood-burning fireplace located in the main floor family room.
  - At the time of the inspection, the Inspector observed few deficiencies in the condition of the wood-burning fireplace in the . It was not operated. Any exceptions will be listed in this report.
- Inspection of wood-burning fireplaces typically includes visual examination of the following:
- Adequate hearth
  - Firebox condition
  - Operable damper
  - Visible flue condition
  - Ember barrier
  - Exterior condition

Full inspection of wood-burning fireplaces lies beyond the scope of the General Home Inspection. For a full inspection to more accurately determine the condition of the fireplace and to ensure that safe conditions exist, the Inspector recommends that you have the fireplace inspected by an inspector certified by the Chimney Safety Institute of America (CSIA). Find a CSIA-certified inspector near you at <http://www.csia.org/search>

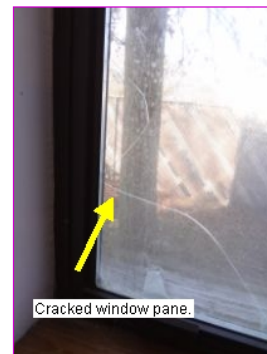
- Condensation visible in the double-pane glazing of a window in the living room indicated a loss of thermal integrity. The Inspector recommends that before the expiration of your Inspection Objection Deadline you consult with a qualified contractor to discuss options and costs for repair or replacement.
- One or more window in the living room had a cracked or broken pane.

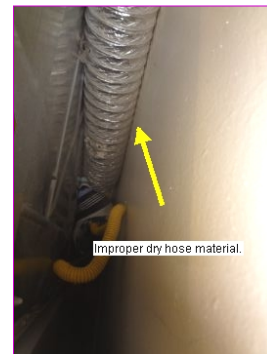
- The dryer was vented using a flexible, ribbed foil vent. This type of dryer exhaust vent is more likely to accumulate lint than a smooth metal vent, creating a potential fire hazard. Excessive lint accumulation can also increase drying time and shorten the dryer's lifespan. The Inspector recommends replacing this plastic vent with a properly-installed, UL-approved dryer vent. All work should be performed by a qualified contractor.
